SYSTEMS REPORT

SOLAR APARTMENT BUILDING

AYLMER, ONTARIO

# **A Community Energy Management Program Report**

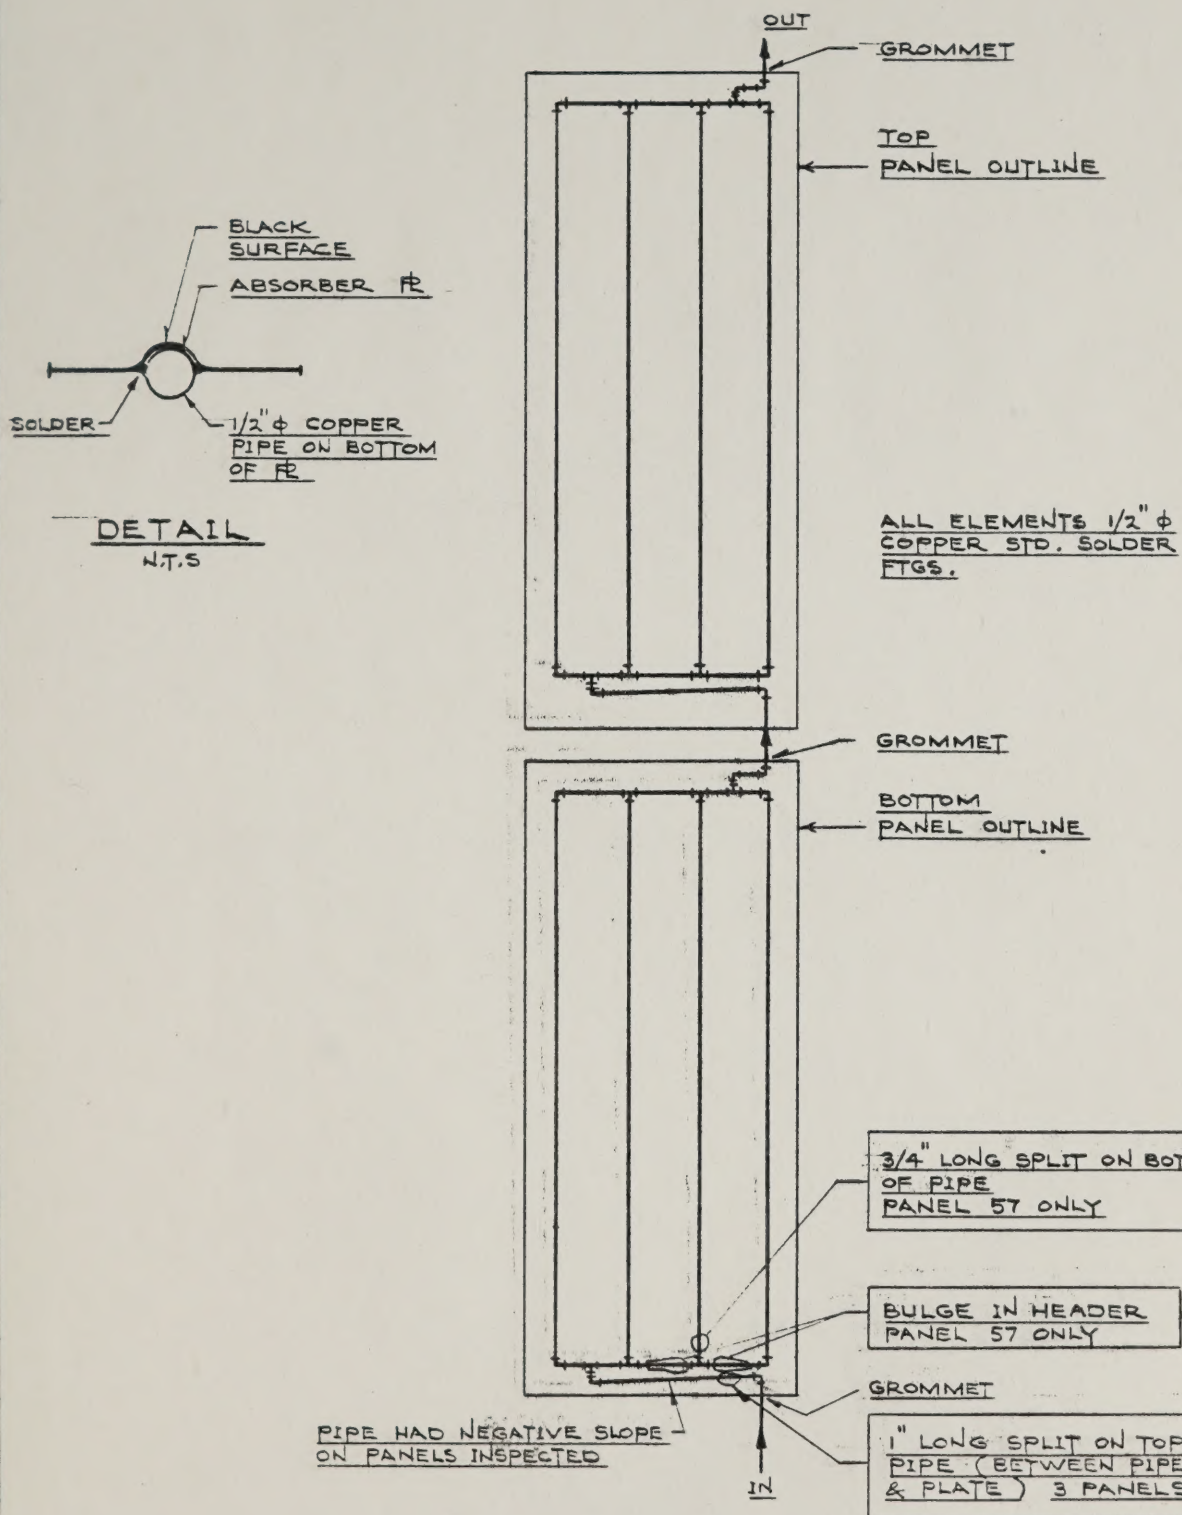
There are 112 solar collector panels with a total area of 218.6 m<sup>2</sup> mounted on the roof at a 60° slope to the horizontal in two rows, one above the other.

Panels are 2.13m high x 0.92m wide with an area of 1.95m<sup>2</sup> each.

Panels are connected in series - parallel with a reversed return system. There are no balancing valves or shut-off valves to individual panels.
